# **Building Penetration Loss Measurements at 900 MHz, 11.4 GHz, and 28.8 GHz**

**K.C. Allen  
N. DeMinco  
J.R. Hoffman  
Y. Lo  
P.B. Papazian**

May 1994

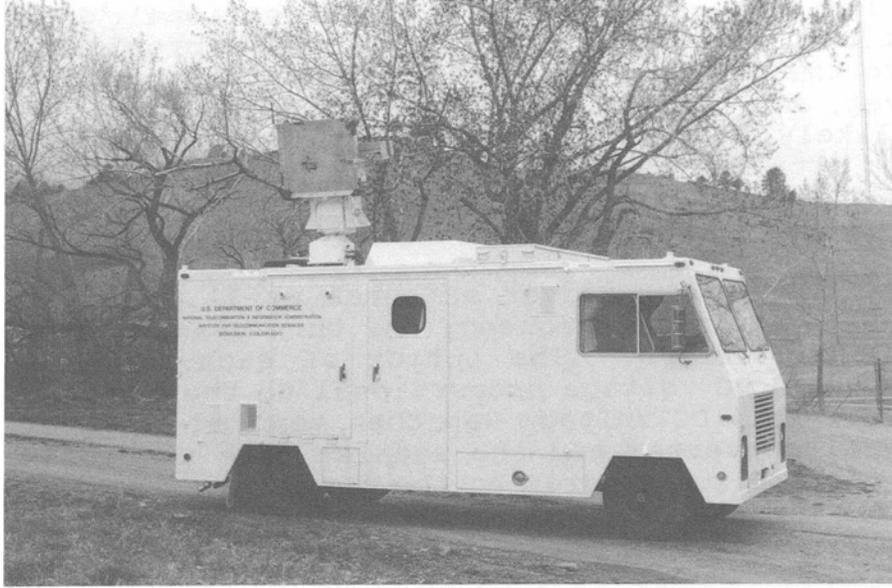
Figure 1. ITS millimeter-wave measurement van (receiver).

The measurement system included three transmitters mounted on a cart that could be moved inside buildings, and the ITS millimeter-wave van located outside the building for reception of the signals. The van is shown in Figure 1 and the transmitter cart is shown in Figure 2. The transmitter cart consisted of three separate calibrated signal generators connected to three separate antennas. The antennas on the cart were omnidirectional in the azimuthal plane to simulate the radiation coverage typical of the small antenna that would be used for a PCS handheld unit. The receiving antennas on the van consisted of two medium-gain horn antennas with 17 dBi at 11.4 GHz and 16 dBi at 28.8 GHz both with vertical polarization, and a vertically-polarized omnidirectional antenna at 900 MHz. The beamwidths in azimuth and elevation of the 11.4-GHz horn were both 22 degrees, and the beamwidths for the 28.8-GHz horn were both 25 degrees. The horn antennas provided adequate angular coverage for receiving most of the multipath signals radiated from the transmitters inside the buildings under test, but favored the direct path and multipath signals arriving within their beamwidths.

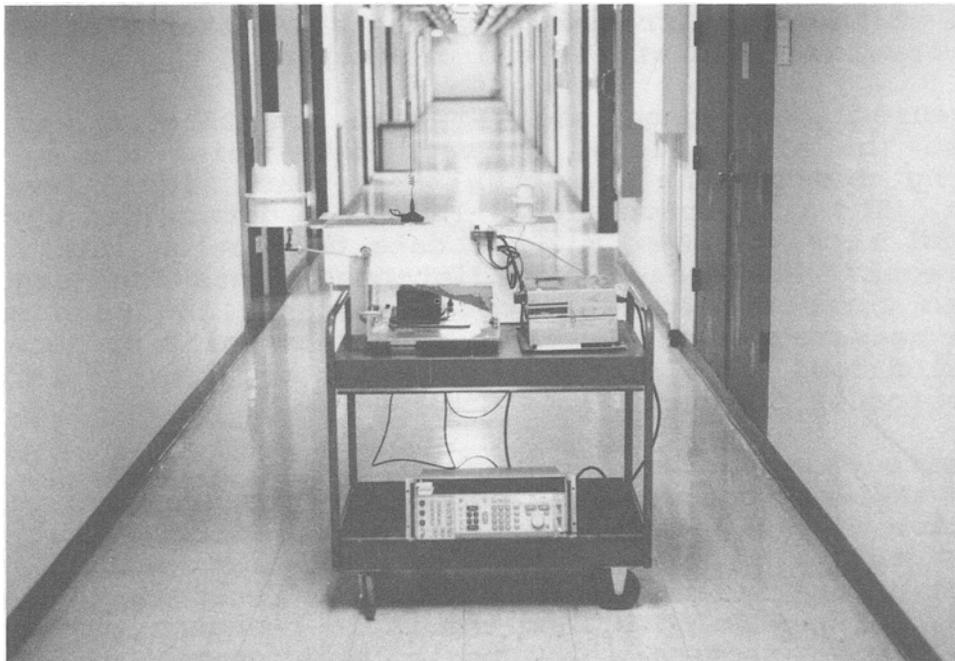
Figure 2. Remote source cart (transmitter).

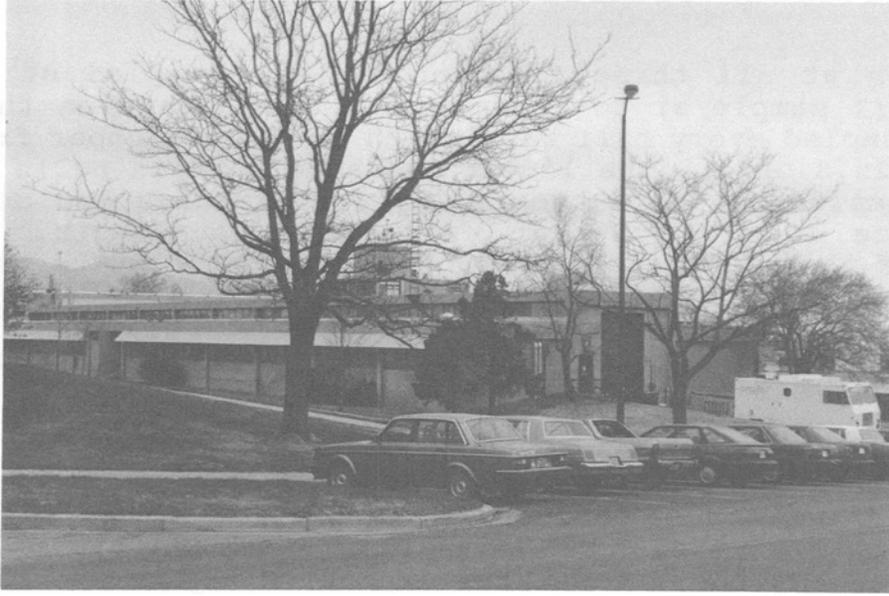
Figure 3. Wing 4 of the Radio Building with ITS millimeter-wave measurement van.

The Department of Commerce Radio Building in Boulder, CO is a concrete structure with steel reinforcement throughout. Wing 4 of the Radio Building is shown in Figure 3, with the ITS measurement van located at the end for the first sequence of measurements. There is a large amount of metal within the building for electrical conduit and structural support. The external walls of the building are concrete with re-bar reinforcement. The interior walls are mostly of cinder block with additional partitions with wood studs and gypsum dry wall. The metal-frame windows in each of the

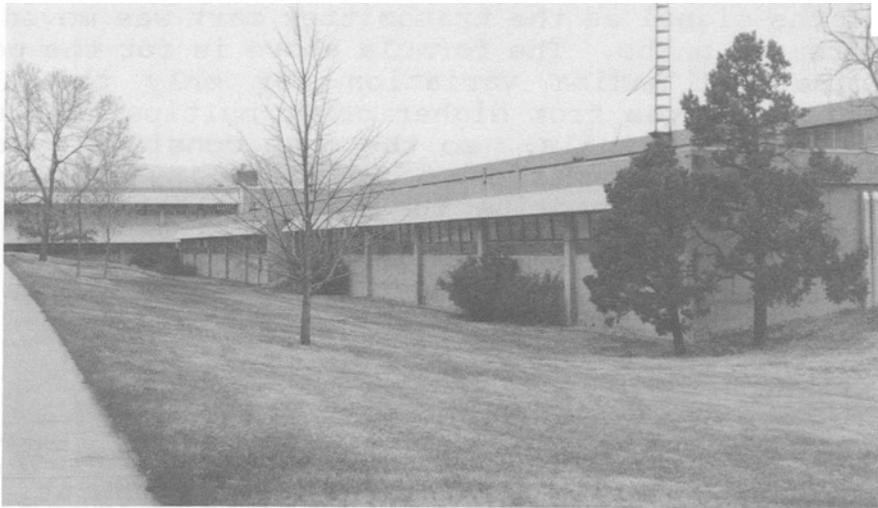
Figure 4. West side of Wing 4 of the Radio Building.

offices cover approximately 6 m<sup>2</sup>. Figure 4 is a view of the west side of Wing 4 showing these windows. All offices in Wing 4 have these windows, and as a result the building may be relatively transparent to the electromagnetic energy from the signal sources when the van was positioned on the side of the building. The office doors are of wood construction with approximately 2.3 m<sup>2</sup> of area. The rooms are filled with conventional metal office furniture including desks, file cabinets, tables, and chairs.

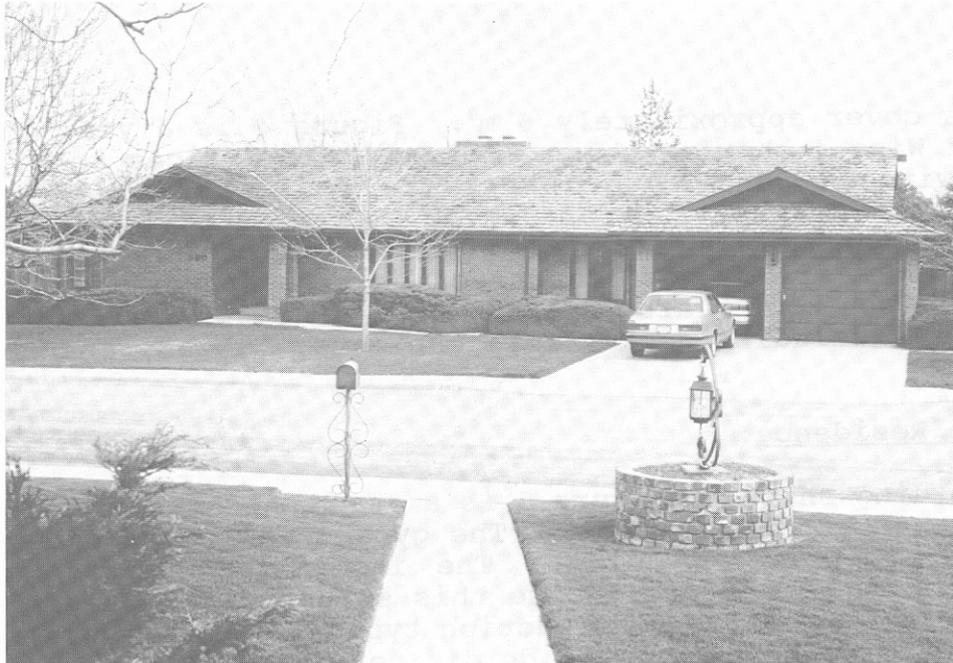
Figure 5. Private residence.

The building shown in Figure 5 is a standard wood-frame house with brick veneer on the outside. The gypsum wallboard did not have a metallic foil on one side. The insulation has a paper vapor barrier. The furniture inside this structure is predominantly of wood and non-metallic construction typical of a private residence. The shrubbery and trees outside did not obstruct the line-of-sight between the transmitter and receiver. Window area on the street side of the house was approximately 4 m<sup>2</sup> per room. There were two major paths traversed during the measurement. One interior wall separated the two paths. The rear path had the exterior wall plus an interior wall between the receiver and transmitter. The front path had just one exterior wall between the receiver and the transmitter.

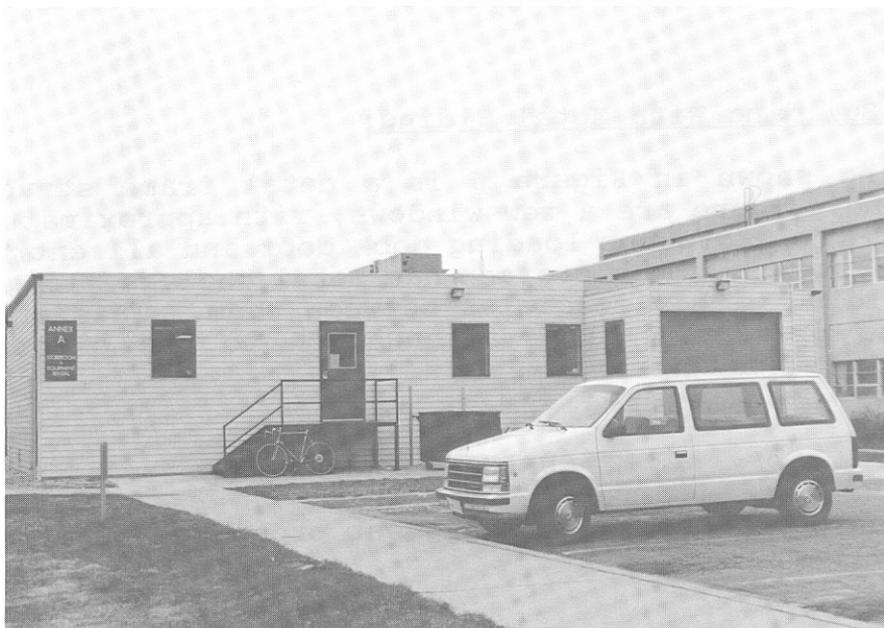
Figure 6. Storeroom with metal siding.

The building shown in Figure 6 is a metal frame structure with metal siding. There are a few windows, with approximately 1 m<sup>2</sup> of area each. The storeroom loading dock door and all entrance doors are made of steel. The storeroom has metal shelves along the width of the building with wide aisles between them. This structure is expected to present a large attenuation to the electromagnetic waves passing through it.

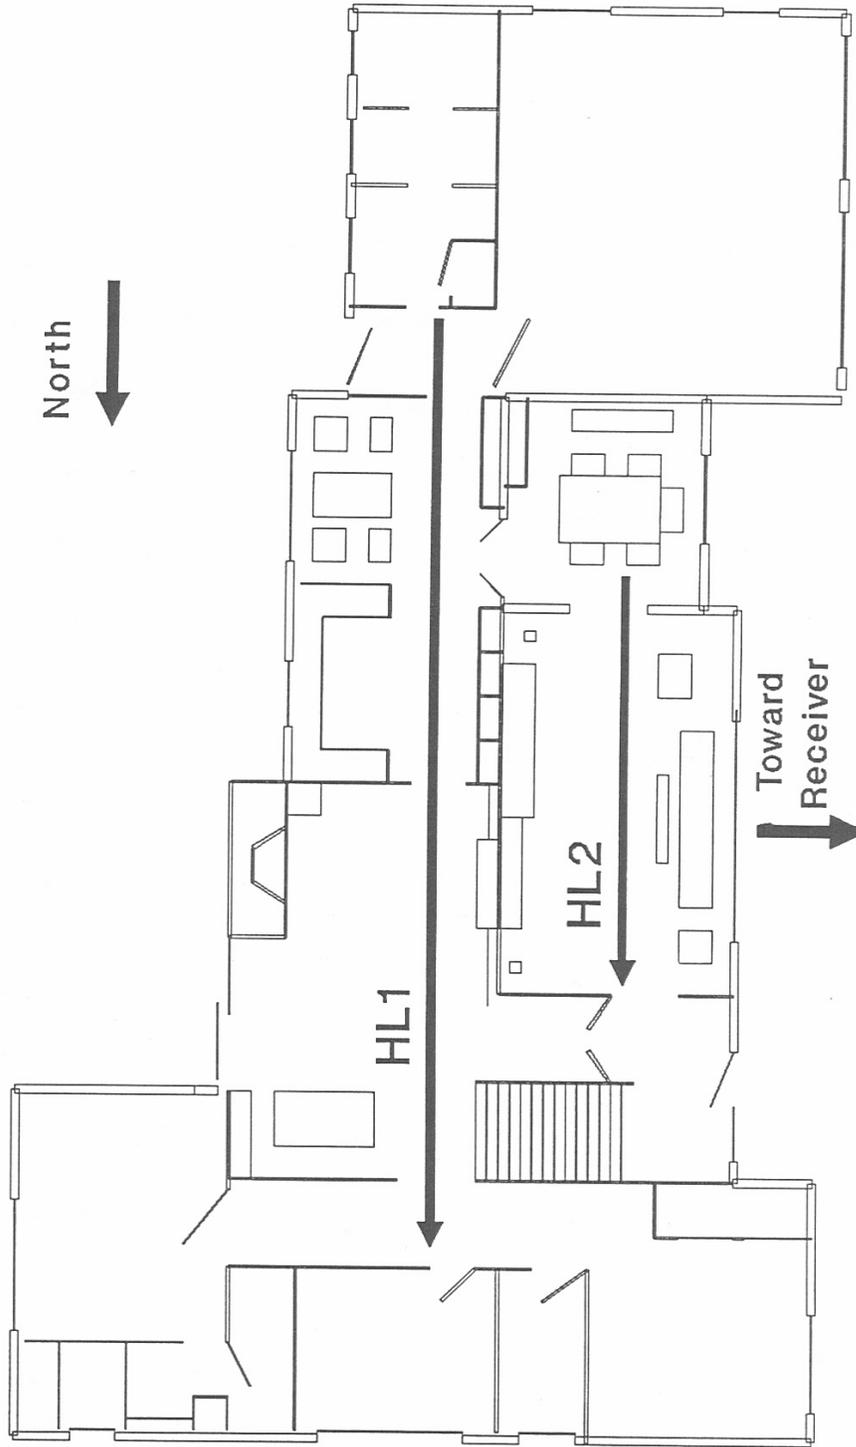
# WOOD FRAME HOUSE WITH BRICK VENEER

Figure 8. Floor plan of single level wood-frame house.

For this building, the van was located in the street approximately 19.5 m from the closest outside wall. The cart was moved through several rooms along a straight line parallel to the street and data were recorded with the van stationary. The distance to the cart from the van was also determined for each data measurement group. The floor plan of the house was convenient for making two such runs and covering most of the length of the house. Figure 8 contains the floor plan with paths traversed during the measurements indicated by arrows. The arrows indicate the direction of the paths traversed during the measurements. The first path passed through the kitchen area and family room in the rear half of the house. The second path passed through the front half of the house through the dining room and living room.

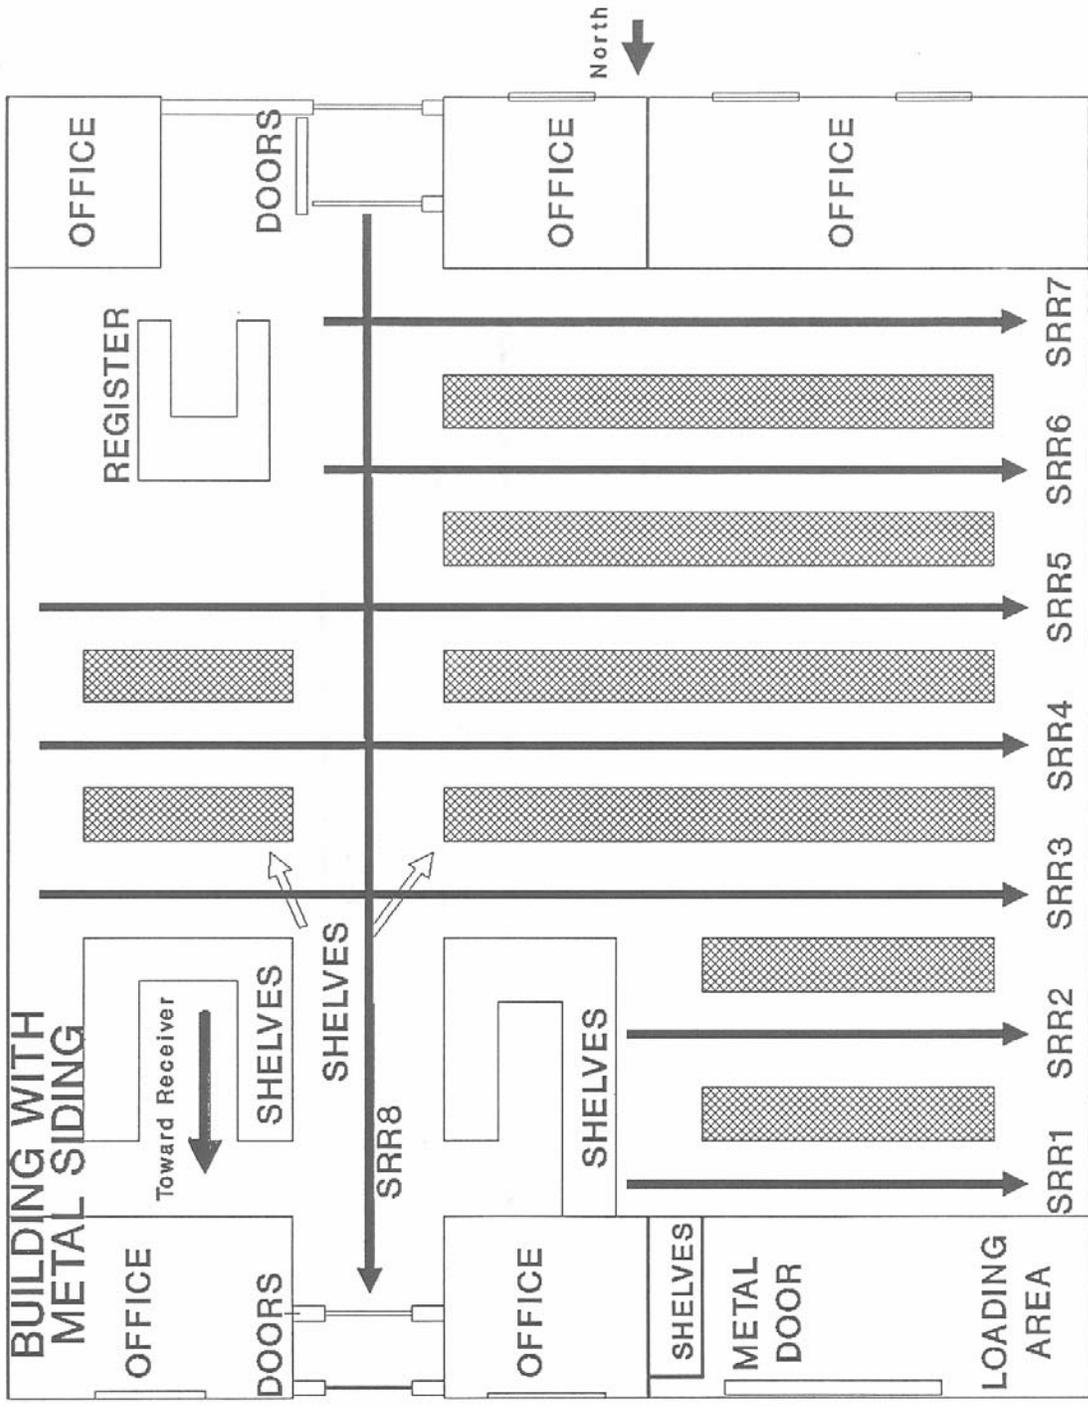
Figure 9. Floor plan of storeroom with metal siding.

For this building structure, the van was located in the parking lot of the Department of Commerce Radio Building between Wings 3 and 5, adjacent to the storeroom and approximately 17.1 m from the door. Figure 9 contains the floor plan of the storeroom with the measurement paths indicated by arrows. The points of the arrows indicate the endpoints of the paths traversed. The source cart was moved up and down all of the aisles inside the storeroom to provide a matrix of data with the variation of electromagnetic energy at three frequencies in two coordinates.
